THE EFFECTS OF THE FAIRBANKS ALASKA FLOOD
ON RESIDENTIAL CONSTRUCTION

January 12, 1972

William C. Cullen
Building Research Division
Institute for Applied Technology
National Bureau of Standards

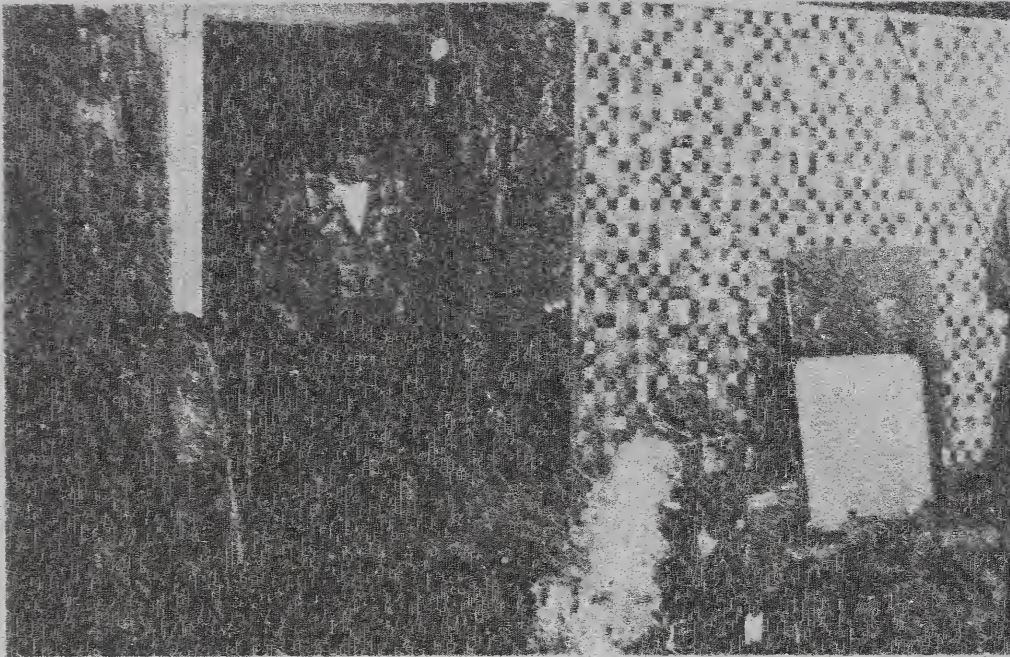
Figure 4 Removal of water should be delayed until the flood water has reached a safe level to prevent interior collapse.

The removal of water from a building as quickly as possible obviously appears to be the first step in the drying process. Experience during the Fairbanks flood has shown that in instances where this was accomplished when the exterior water-level was at ground level or above, serious and costly basement floor and wall problems were created by differential hydrostatic pressures between outside and inside. Therefore, removal of water should be delayed until such a time the water has reached a safe limit.

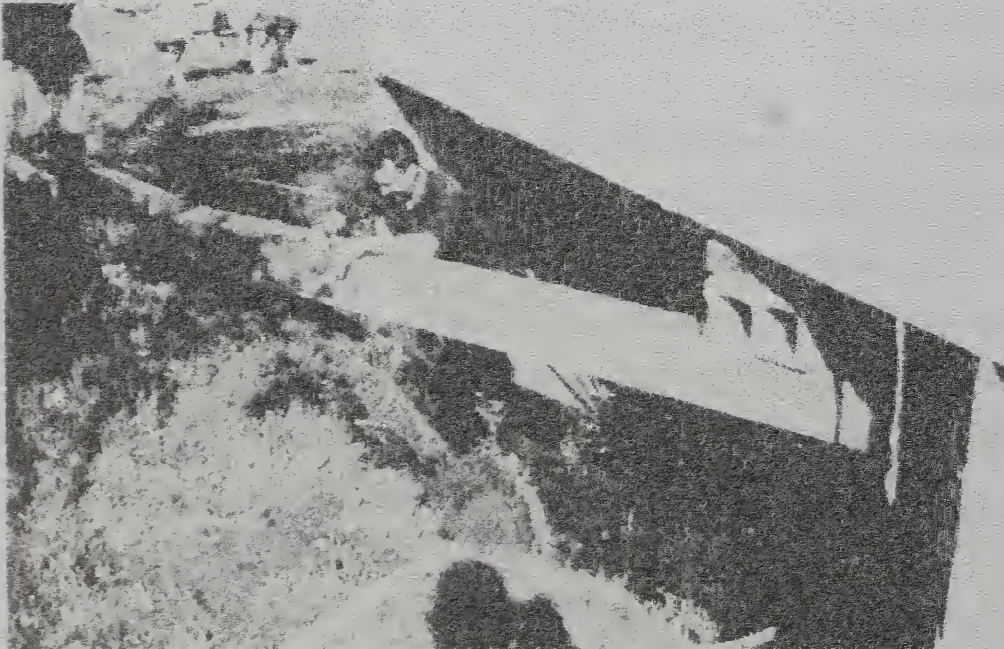
Ironically the immediate action implemented by the conscientious homeowner to keep his basement relatively free of water during the initial stages of the rising of the flood water, frequently resulted in the most serious and costly flood damage observed in residential houses. In some cases, the foundation walls actually imploded due to the hydrostatic pressure against the exterior walls. In others where the basement walls were sufficiently strong to resist the forces generated by the differential pressure, the basement floor actually heaved and cracked.

Figure 5 Collapse of basement wall due to hydrostatic pressure against exterior wall. August 1967.

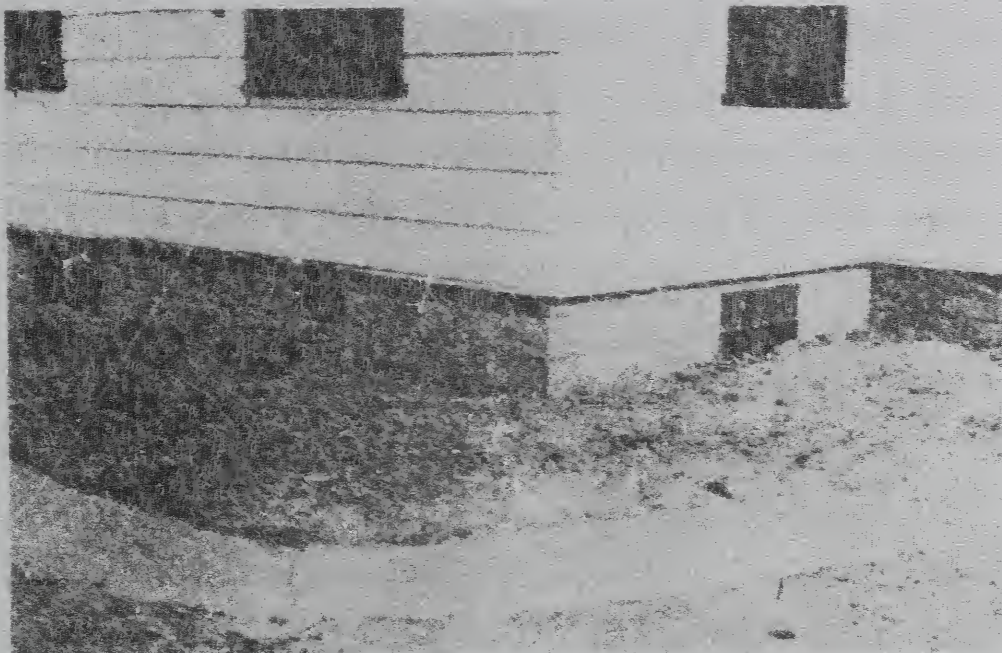
Figure 6 Restored basement wall shown in Figure 4.
May 1968

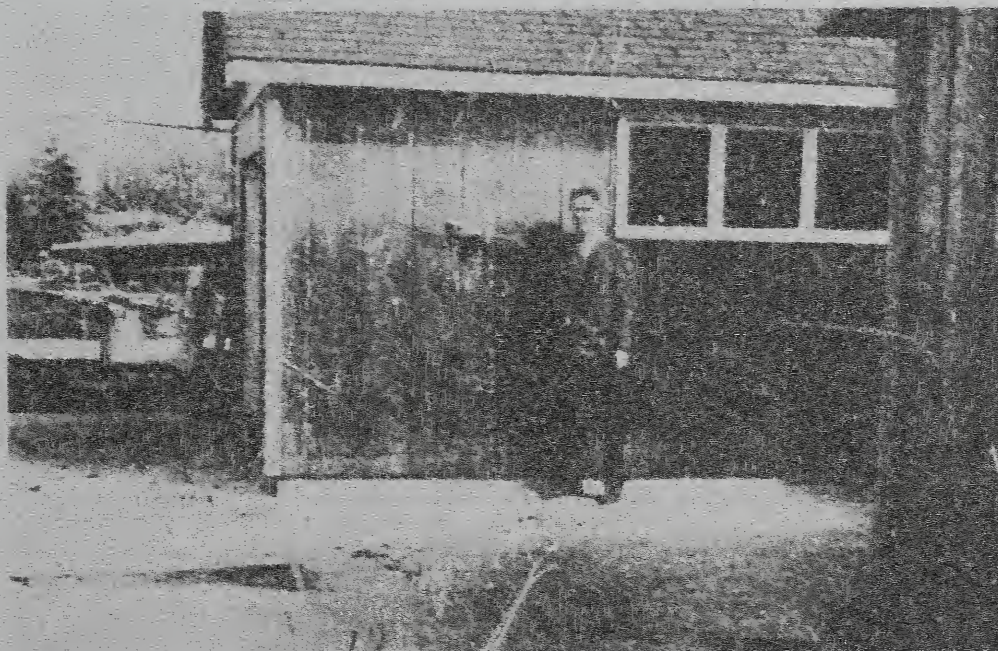
Figure 7 High-water mark exceeded five foot level
in some cases.

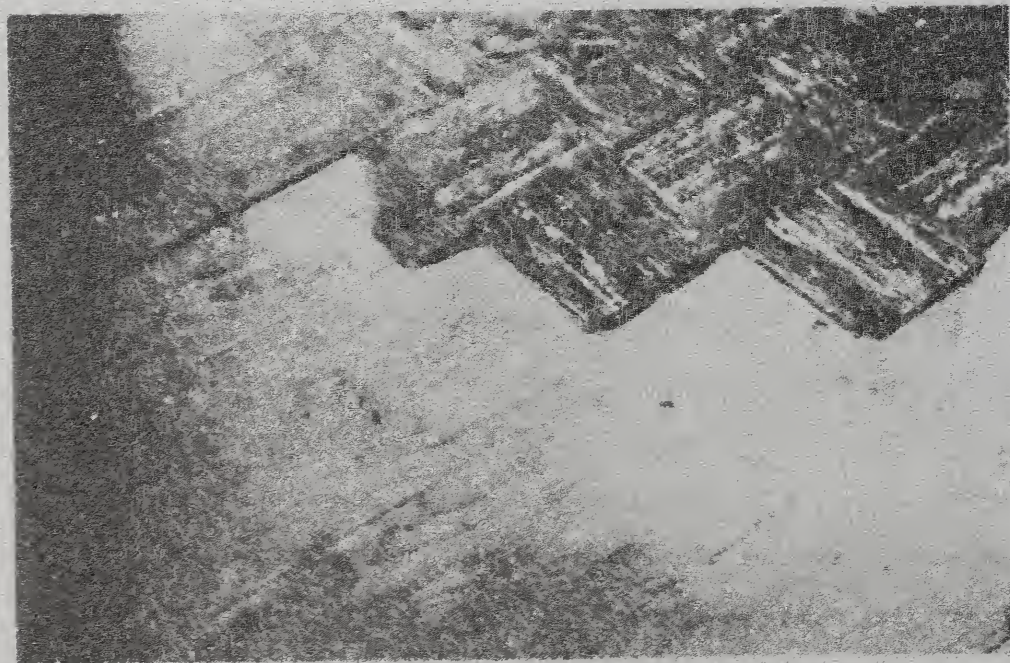
Floor coverings and subflooring were adversely affected by the flood water. In almost every instance the coverings including asphalt, vinyl and vinyl-asbestos tiles, sheet vinyls and textile type carpeting were soiled and damaged. The most common type of damage observed with the resilient type coverings was a failure of the adhesive used to bond the tiles to the substrate. The performance of the subflooring was certainly a factor in the performance of both the finished floor covering and the adhesive selected for its application. In cases where the substrate was concrete or exterior grade plywood and a water resistant adhesive was employed, it appeared that the flooring systems resisted major damage other than that due to soiling. However, where delamination or warpage of interior grade plywood occurred or where a water susceptible adhesive was employed, removal and replacement of the damaged flooring was indicated.

Figure 9 Failure of adhesive used to bond floor tile to substrate.

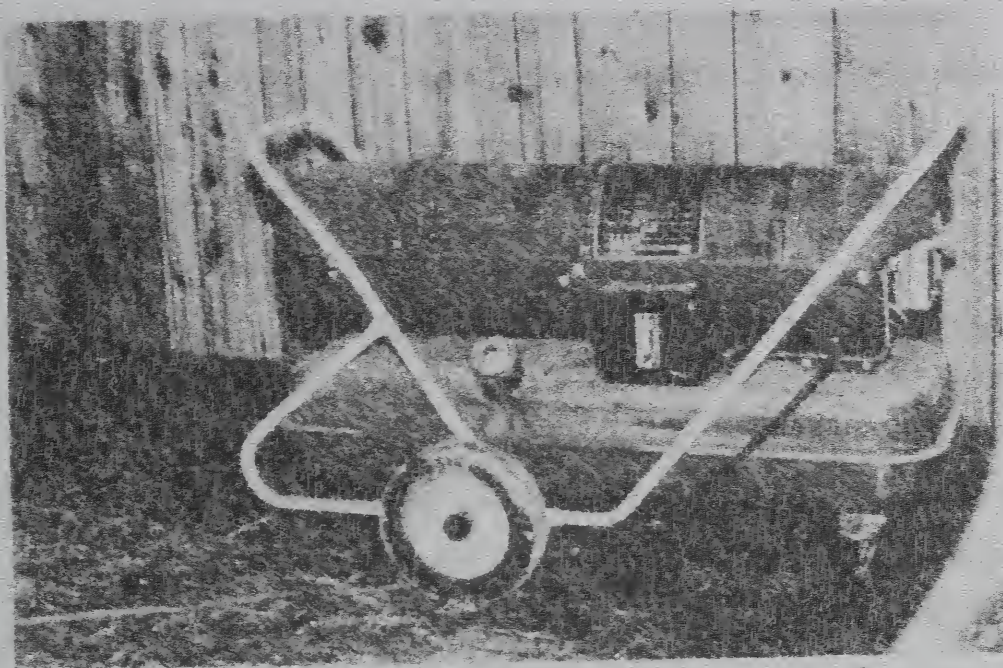
Figure 10 Supplementary heating in the form of portable units proved to be effective in the drying operation.

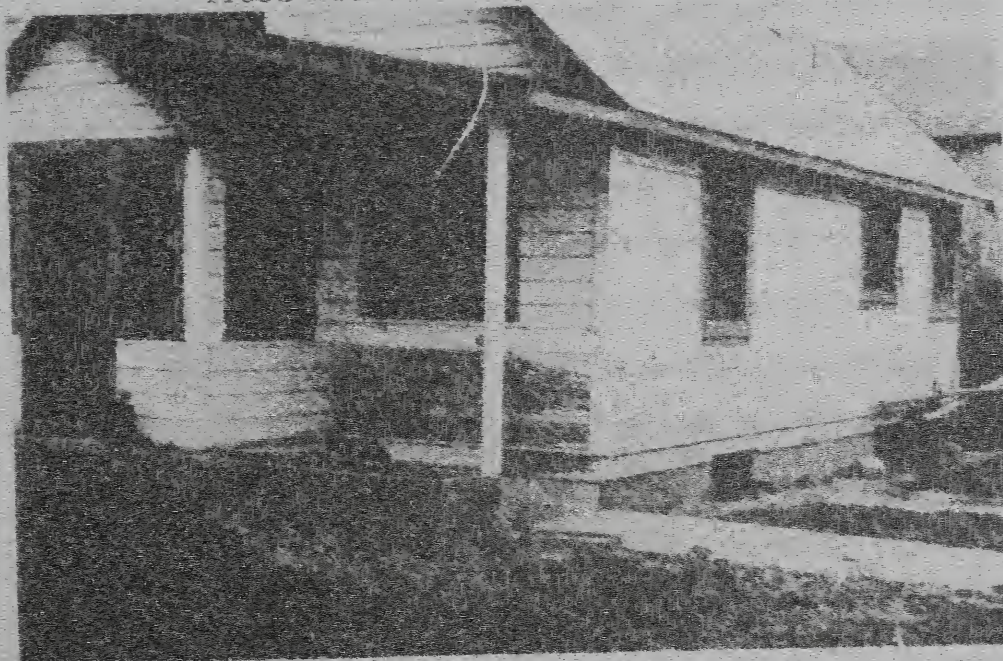
Figure 11 Paint failure clearly indicates level of flood waters. May 1968

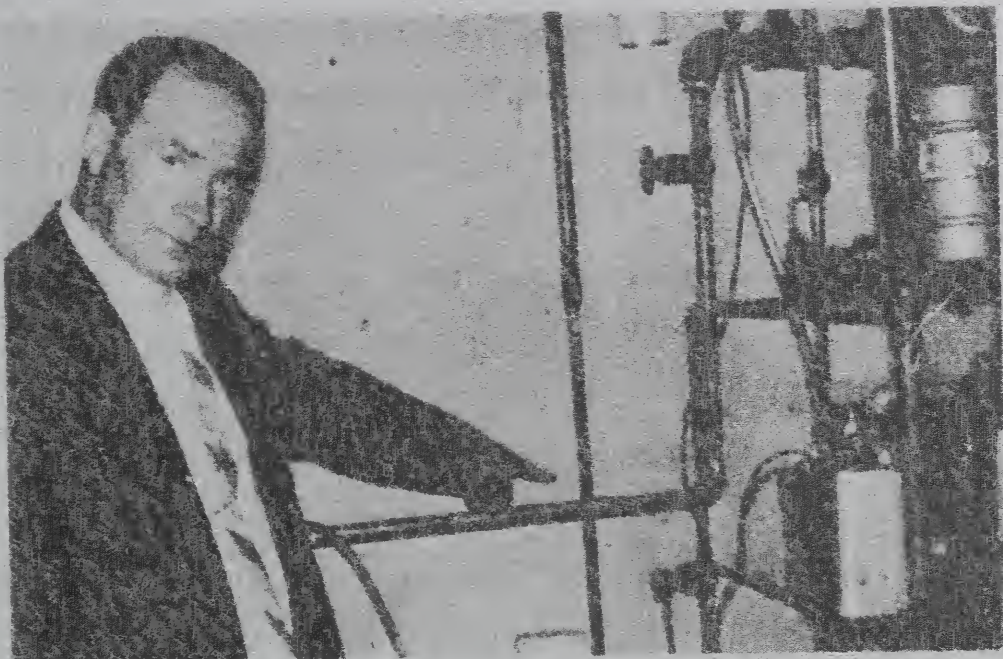
Heating systems which were completely submerged for a number of days functioned in a satisfactory manner after being cleaned and dried. The cleaning procedure for electric motors, burners and controls consisted of flushing with water, drying, treating with a water-displacement liquid and placing in service. As expected there was a high incidence of premature failure of various parts of the system such as bearings in motors, contacts in coils, etc. during the subsequent heating season. The failures were mainly attributed to abrasive silt and corrosion. The important fact remains that despite the severe exposure conditions, the systems upon drying, were able to function when the need for heat was most critical.

Figure 14 Furnace units which were completely submerged for a number of days functioned after cleaning and drying.

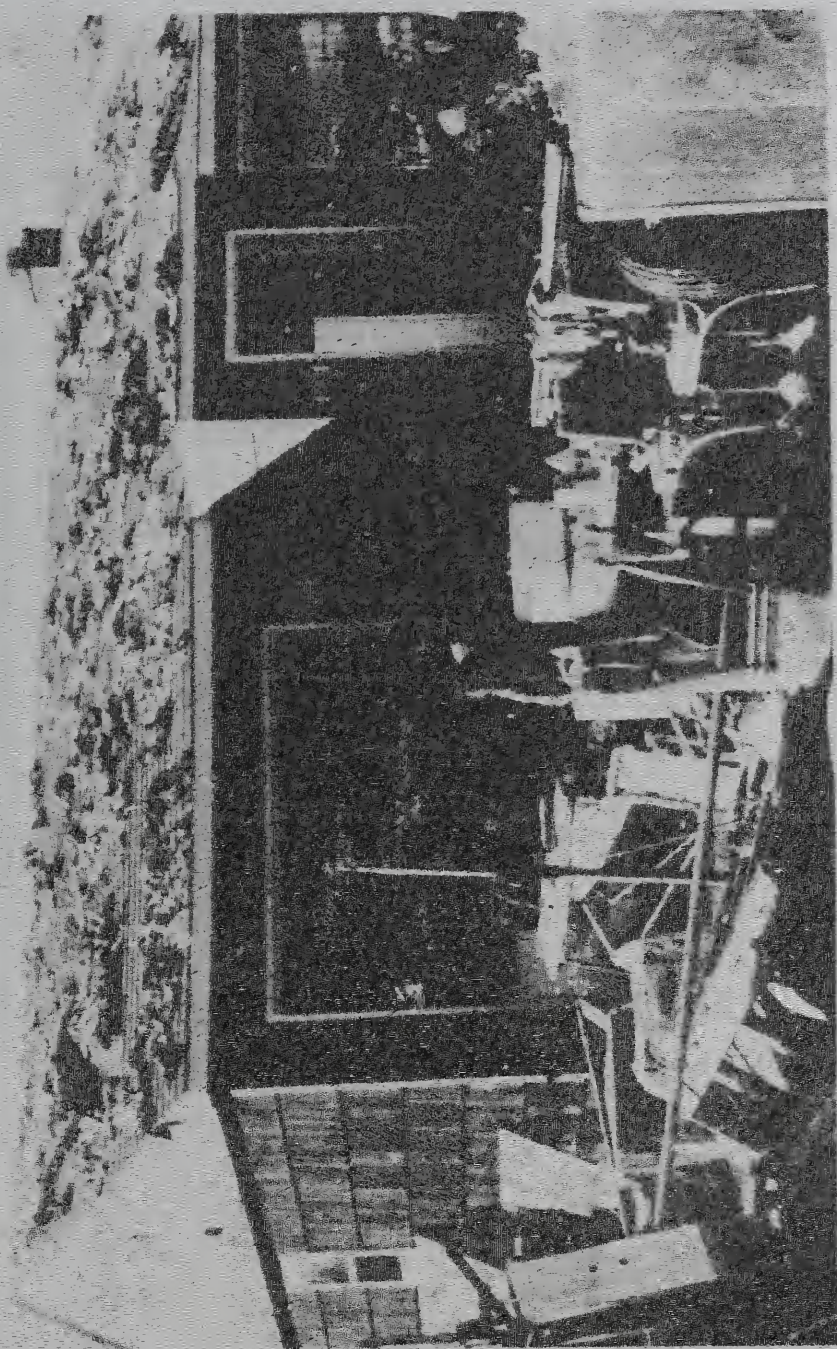
Figure 16 In addition to building damage, flood victims suffered large losses in clothing and household effects.
